Dry Fire Hydrants

Repair of 6-inch DFH
Gillis Falls Road
Mt Airy, Maryland

Dry Hydrant Repair

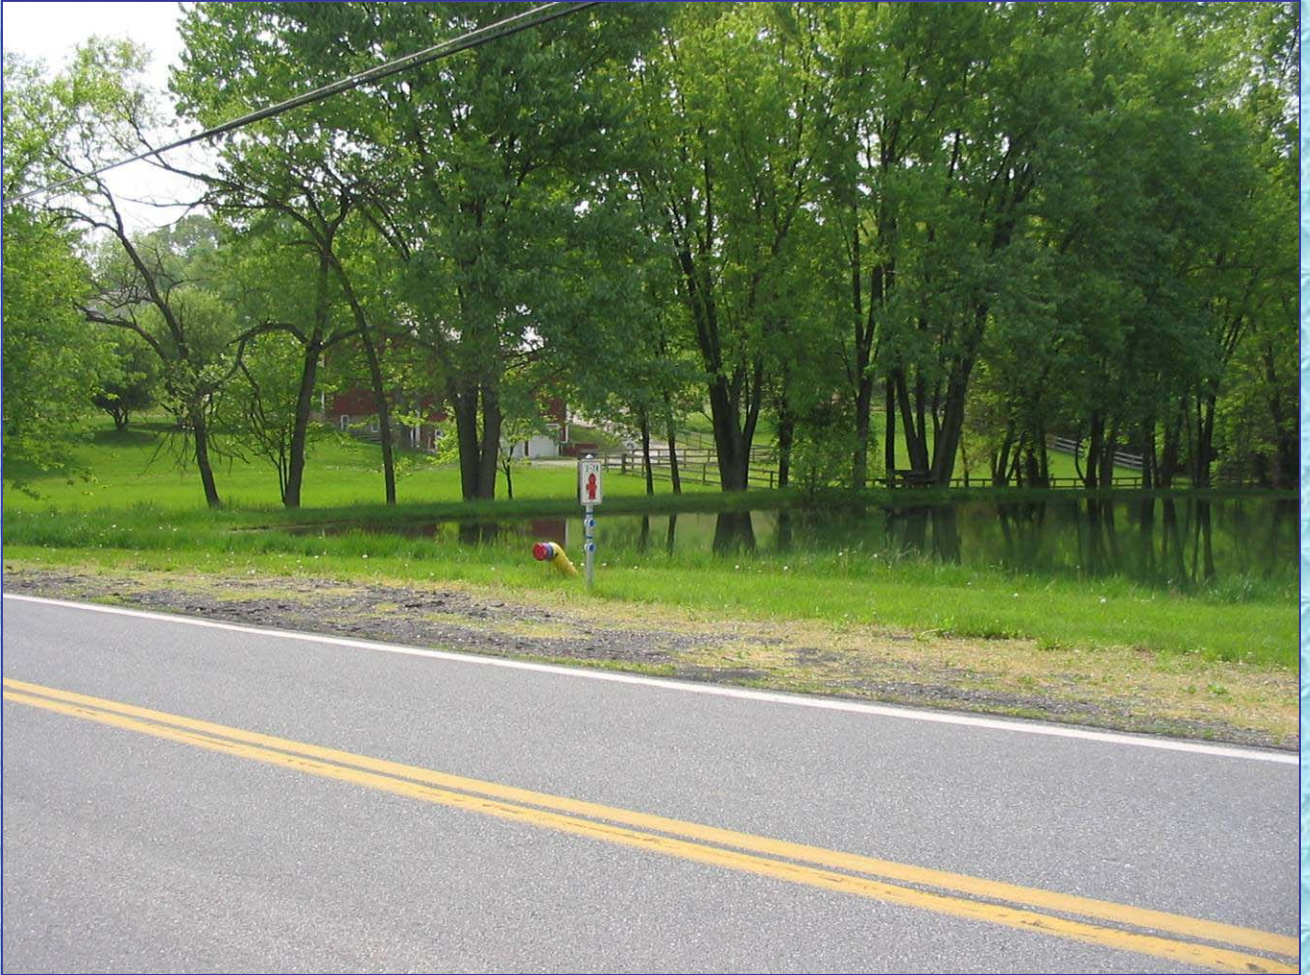
This DFH in Mount Airy, MD did not always look like this. Some time after installation, an air leak developed at the suction head connection to the PVC pipe. GBW Associates, LLC were contracted to repair the DFH.

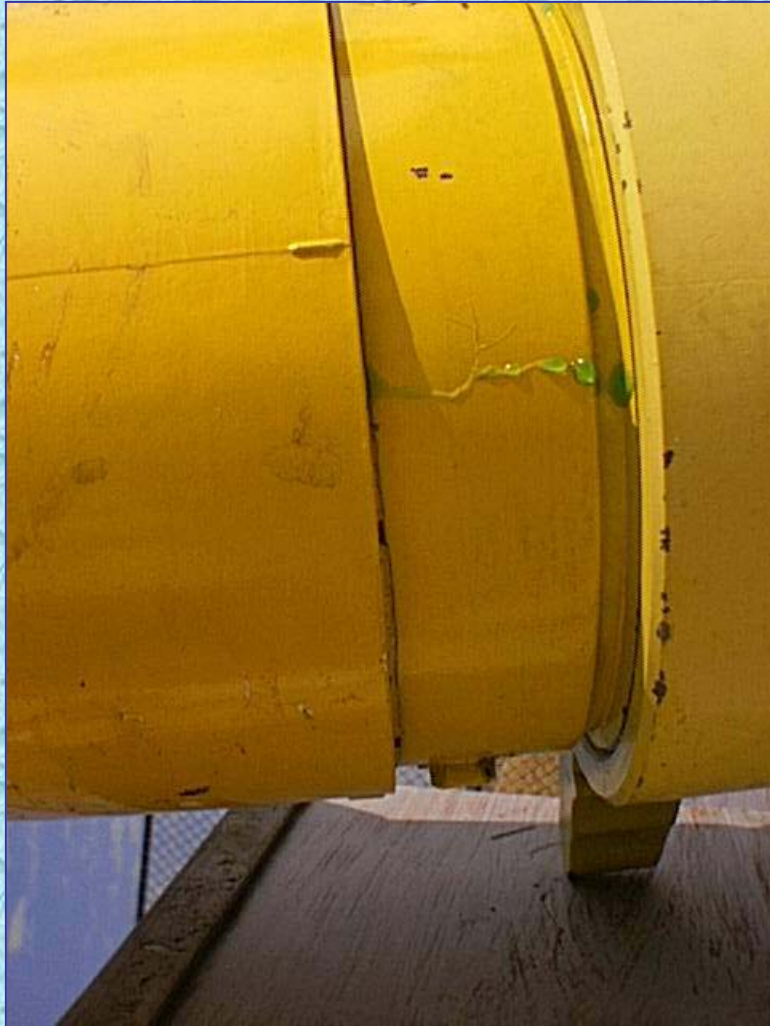
The Air Leak

The air leak in the original head occurred at the interface between the metal and the PVC. Basically, the PVC cracked and could not be repaired.
