# Dry Fire Hydrants

Snow Plow 1 - Dry Hydrant 0

A Not So Simple Repair!

Lineboro, Maryland

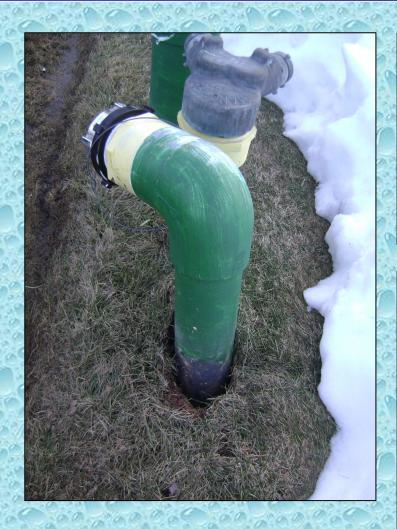
The site was a 30,000 gallon underground tank located in a small housing development outside of Lineboro, Maryland. The tank had been installed to provide water for fire protection. The suction pipe was reported to have been damaged by a front-end loader.

Our initial inspection clearly revealed that the suction pipe was a bit catawampus and probably sheared off below ground. The questions of course were: "Where was it sheared, was the flange damaged, and was the tank damaged?"

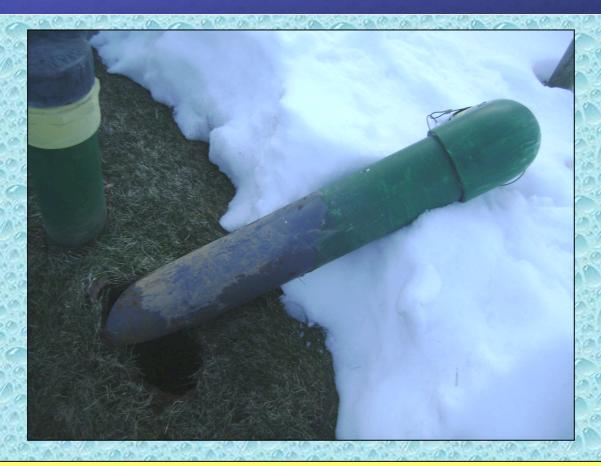
So, the inspection crew confirmed that the suction pipe was sheared off pretty far down and quite possibly at the flange. The top of the tank would have to be exposed in order to assess all damage.

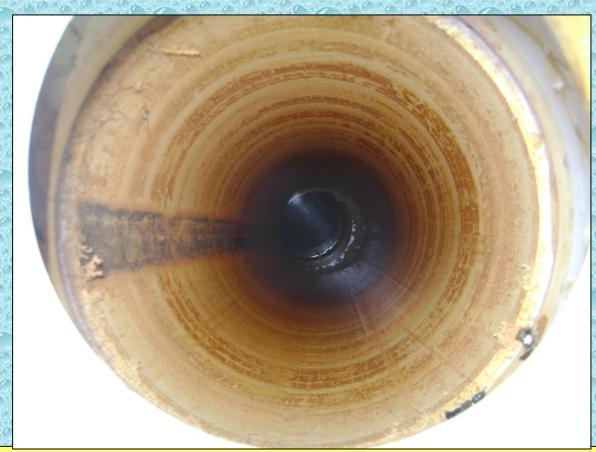
Looking down the vent pipe, we could see misalignment at the water level which meant that the vent pipe was also broken.

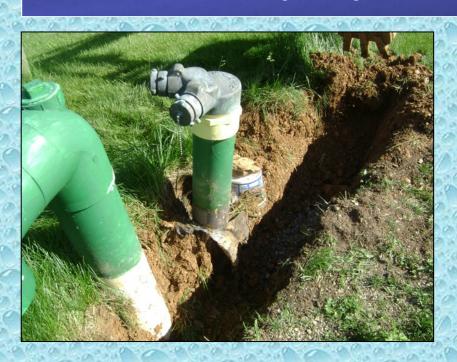
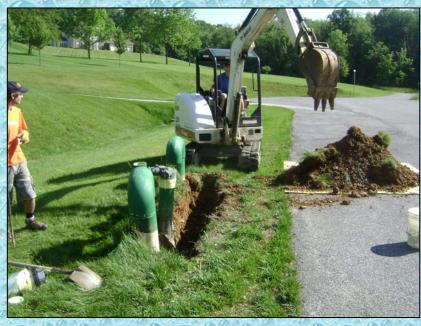
Once we got near the top of the tank we found that the fill pipe was also sheared at, or near the flange. That now meant three of the four pipes were broken...a bit different than just the suction pipe being cracked.

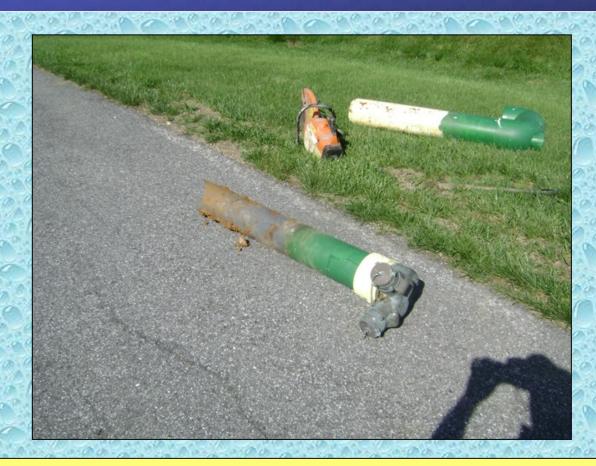
The broken fill pipe and vent pipe. Both had radial types of shears that most likely indicate a striking and lifting motion by some type of shovel/bucket machine – a front-end loader most likely.

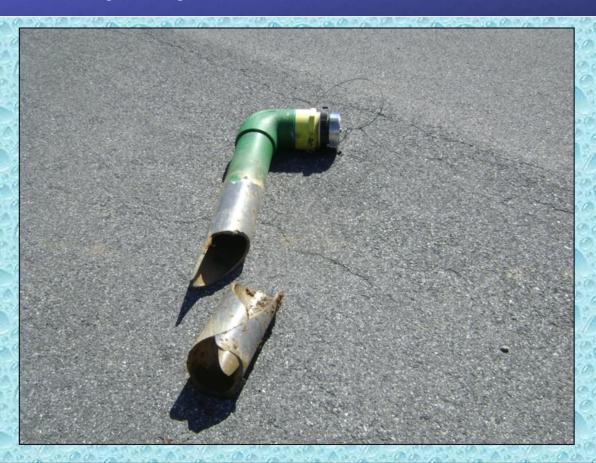
The suction pipe was clearly the most damaged of the three but all required the same repair – complete replacement – including the flanges.

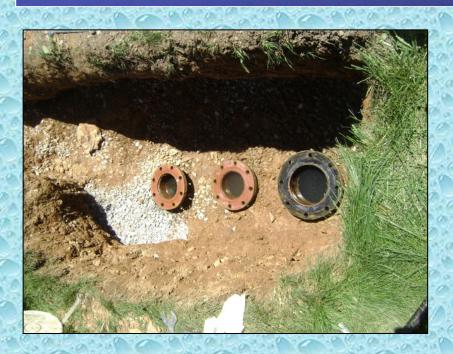
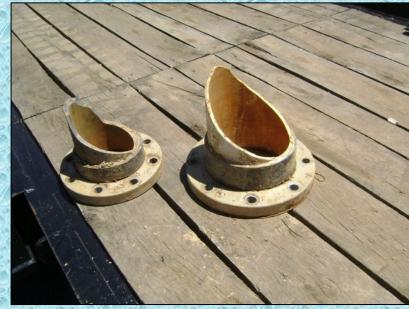
The three broken pipes were all broken at the flange – which meant that the flanges had to be replaced as well. FORTUNATELY – the tank flanges were not broken.

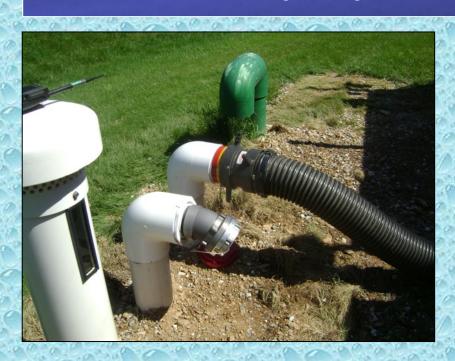
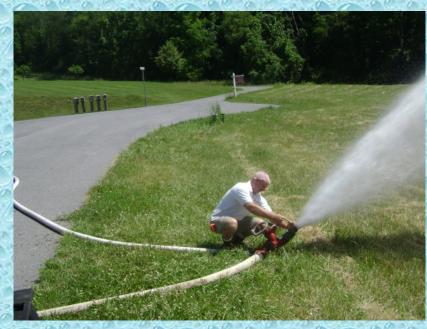
The tank flow tested right around 1,000 gpm with some debris found in the pipe. The debris was small pea gravel and most likely entered the tank when the pipe was pulled out of the tank when struck by the loader. Oh – did we mention that a neighbor stopped by during the flow test and said that the loader had ripped the pipe out and that he put the pipe back into the hole a couple days later. Thus – the gravel falling into the tank.

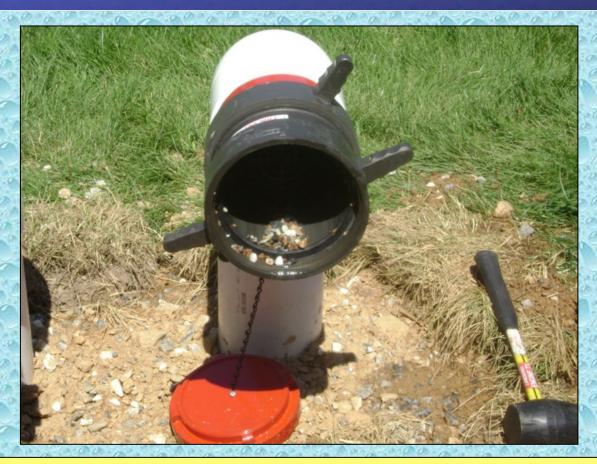
Some of the gravel found after the strainer was removed. Fortunately, a second flow test showed marked improvement after the cleanout.
