# Dry Fire Hydrants

Snow Plow 1 - Dry Hydrant 0

A Not So Simple Repair!

Lineboro, Maryland

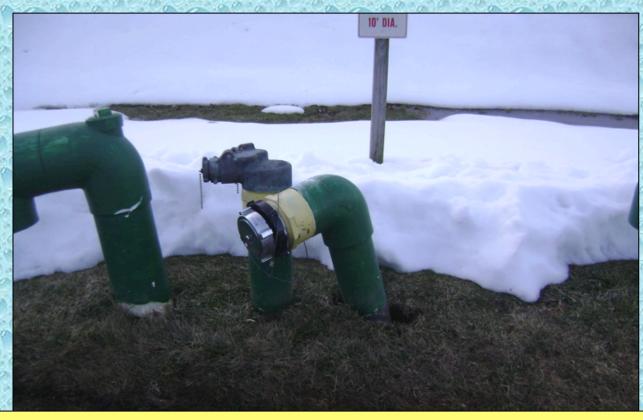
The site was a 30,000 gallon underground tank located in a small housing development outside of Lineboro, Maryland. The tank had been installed to provide water for fire protection. The suction pipe was reported to have been damaged by a front-end loader.

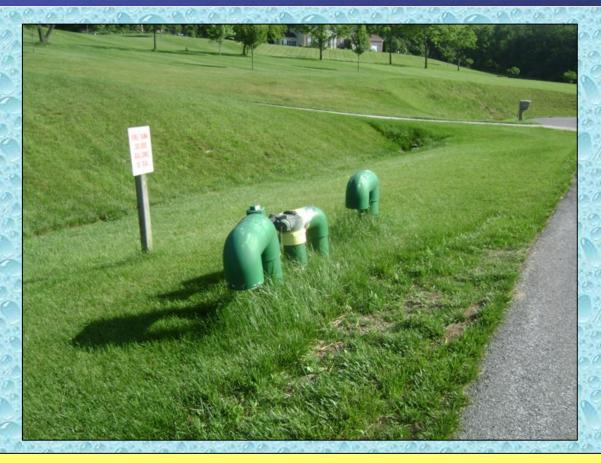
Looking down the vent pipe, we could see misalignment at the water level which meant that the vent pipe was also broken.

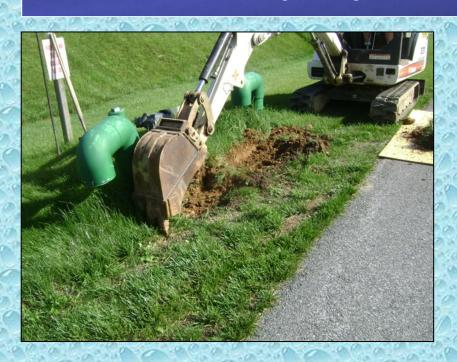
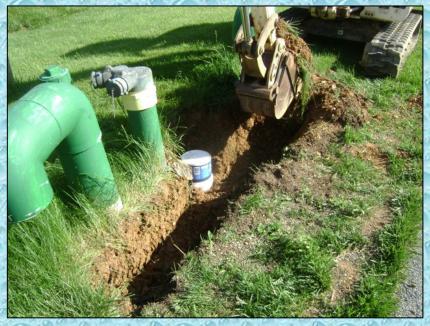
The goal was to dig as little as possible and to get close to the flanges and then dig by hand. As with anything, that plan went sour when we found more damage than initially thought – so…much more digging was needed.

Because of the need to expose the top of the tank, we elected to use a mini excavator to handle most of the digging. These small machines have really made it so much easier to work on dry hydrants.

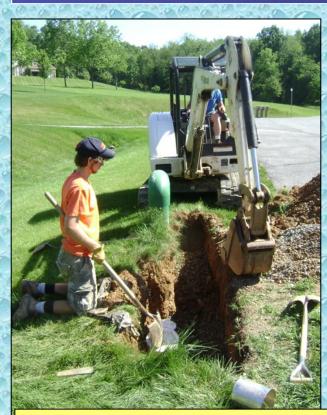
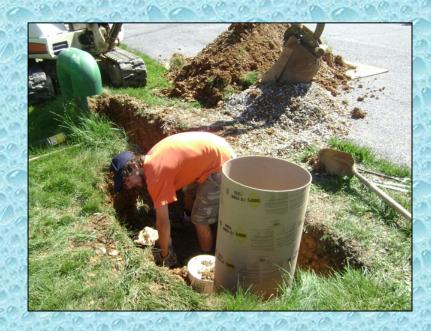
The suction pipe was clearly the most damaged of the three but all required the same repair – complete replacement – including the flanges.

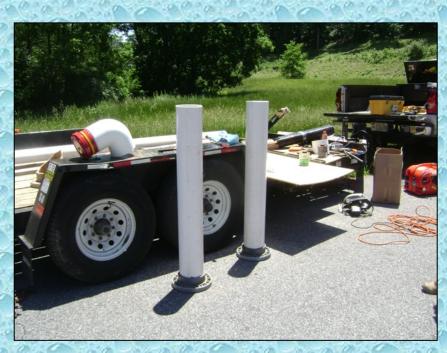
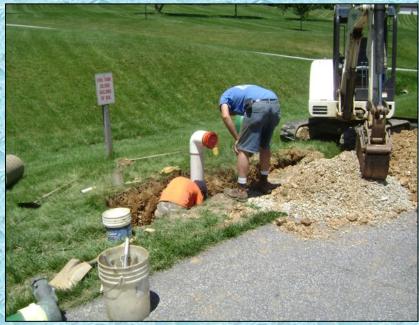
The three broken pipes were all broken at the flange – which meant that the flanges had to be replaced as well. FORTUNATELY – the tank flanges were not broken.

With the arrival of new flanges, work was started on cutting and gluing and installing the suction and fill pipes. However, the unexpected damage to the fill pipe would require a special order which would delay completion of the project until another day.
